Unified Fire Authority Green Sheet

Oxygen Tank Explosion and Subsequent Fire

8/19/2024 Approx 1100

MA113 and ME113

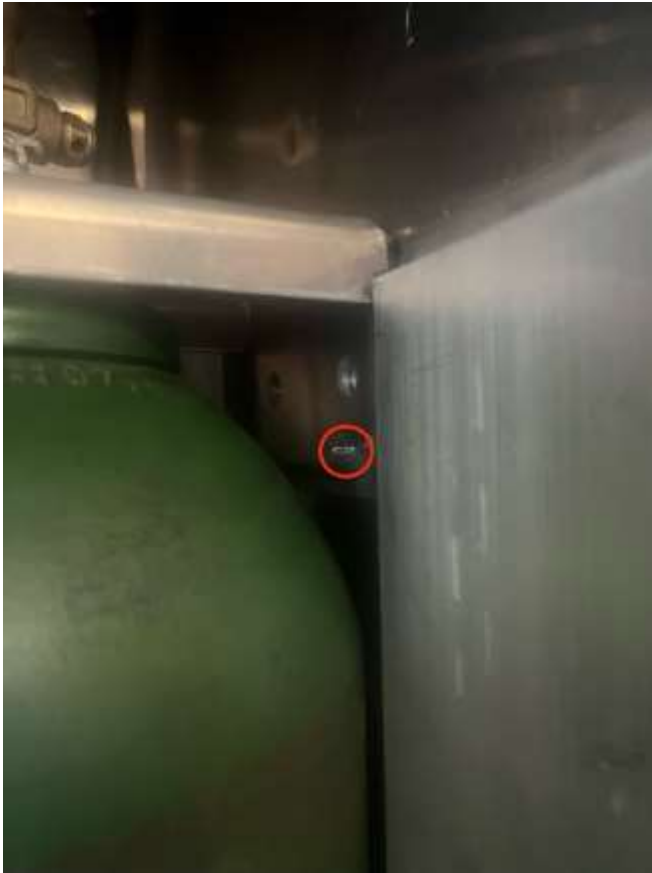
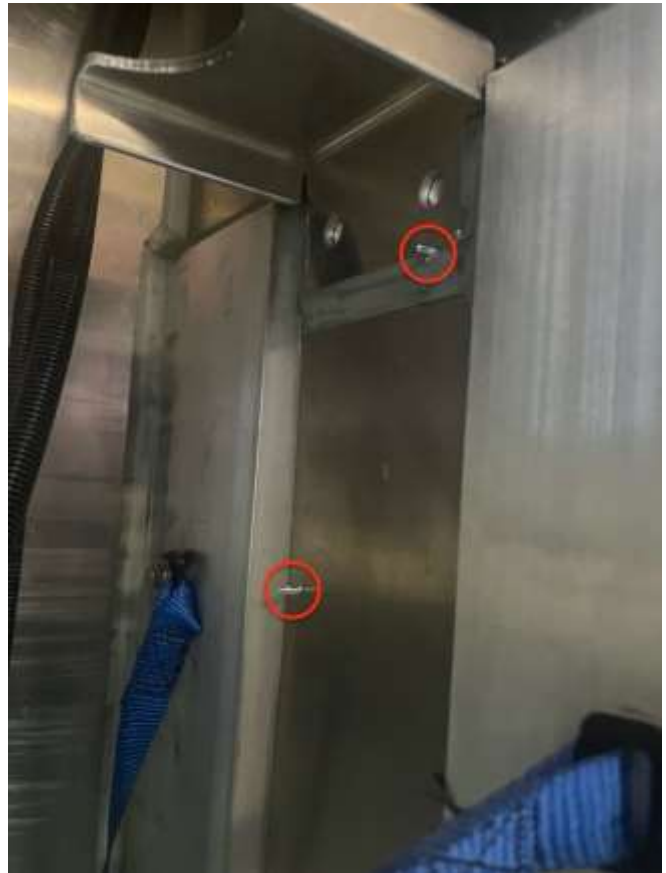
Images A1 & A2

Using self-tapping screws on a project of this nature may not be the best way to secure the safes or similar items in the future and should be only utilized when necessary. This also creates snag hazards and rub areas (Images A1&A2) that can wear down equipment or tanks that are resting up against the self-tappers day-to-day.

It has been identified that UFA had unknown close calls on a couple of the ambulance modifications. This is primarily with the Dodge chassis and the Frazier box setup. Several of the oxygen tanks were nearly drilled into on the sidewall, which most likely would have been more catastrophic. All ambulances should be checked following this incident. If any self-tapping screws are identified, make note of this immediately in Fleetio and inform the station officer of the identified issue. See the images below for an example:

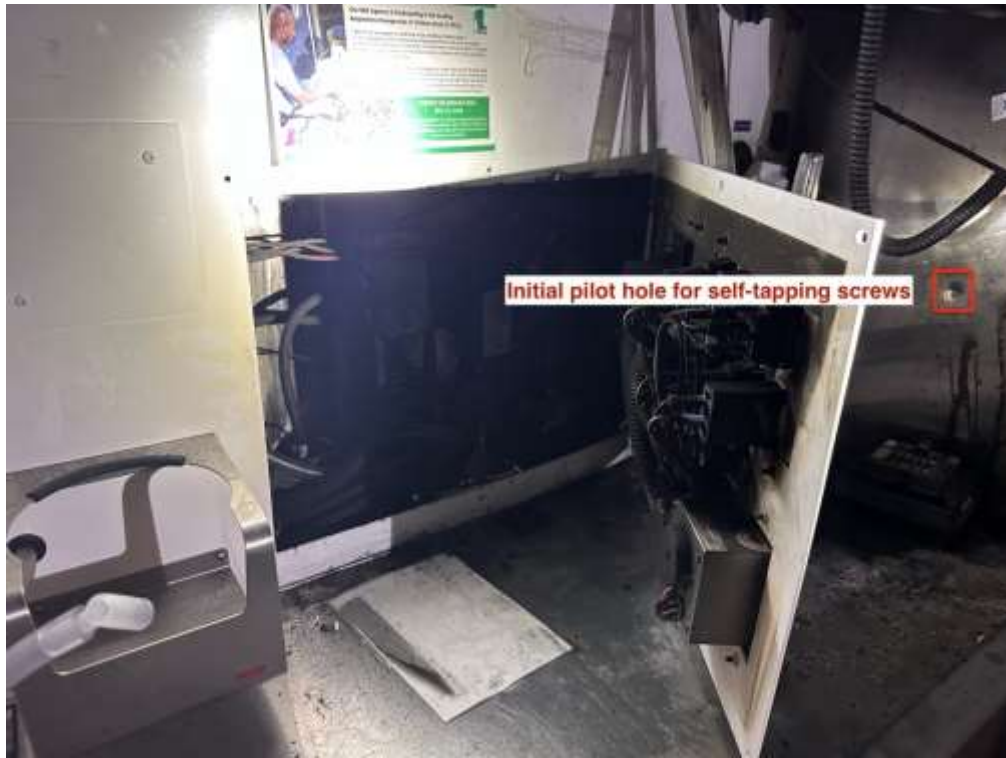
The employee performing the drilling was thrown backward against the other side of the patient compartment and reported seeing a wall of flame wrap around the ambulance as the rear doors were open. The fire also breached the interior access panel that can be seen in image 1.

Image 1 - Pilot Holes from Patient Compartment

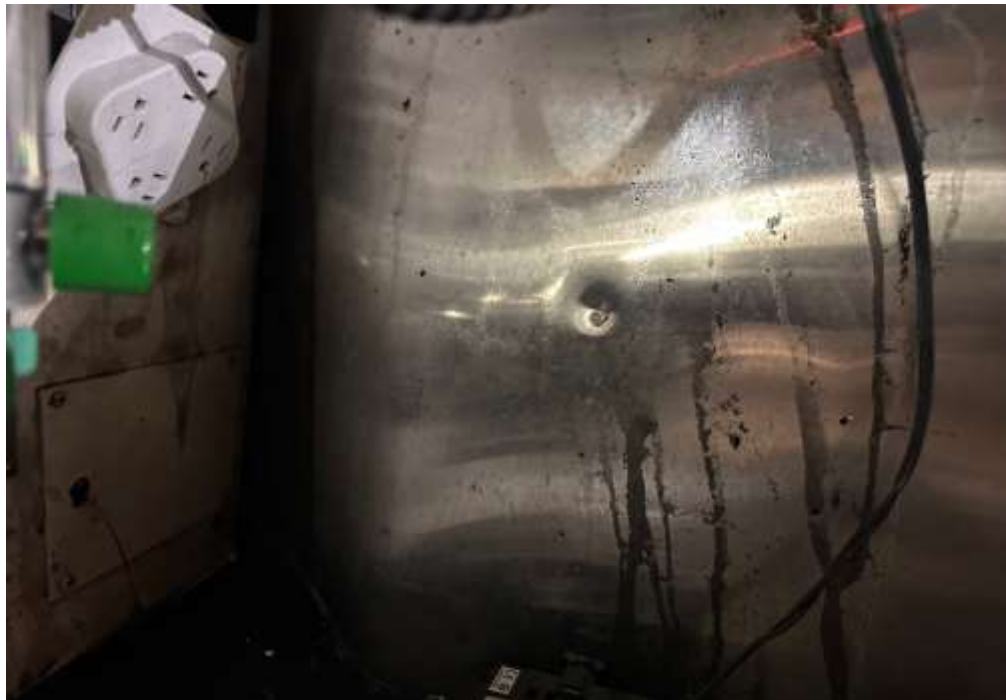
Image 2 - Pilot Hole Close-up

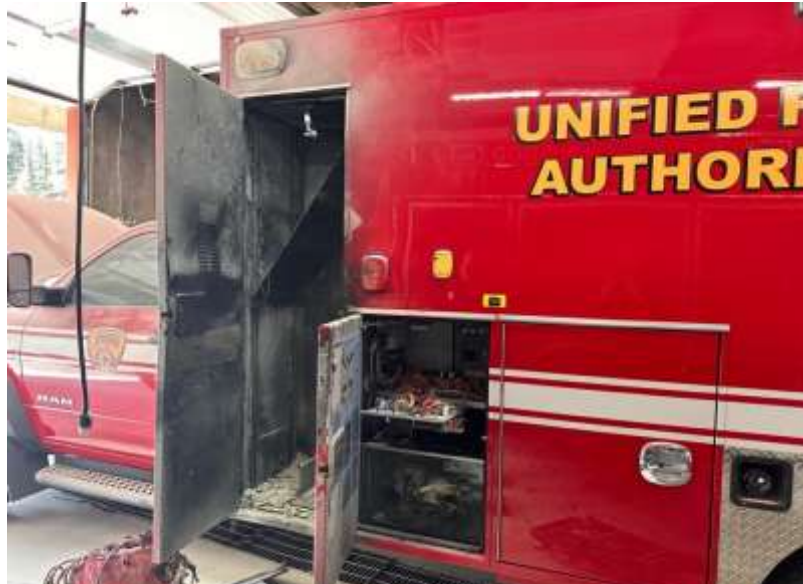
In the haste to get the project completed, and having experienced no issues on previous installs, there was some self-identified complacency on the part of the Employees. Also, due to not being at Logistics, the drill bits on hand were slightly different from those previously used. As one of the employees started the wiring and the other began drilling the pilot holes. The employee doing the wiring had the smaller compartment open (driver-side compartment #2 or D2) with the drop-down door to the electrical equipment open and had their head in the area working on the electrical connections (see Image 5).

The employee on the ambulance's exterior still had their head within the D2 compartment, with the interior shelf dropped down (images 5 and 6), working on some wiring when the explosion occurred. When the massive flame and explosion occurred, the employee sought safety in the back of the bay, away from the fire.

Image 5 - View of MA113

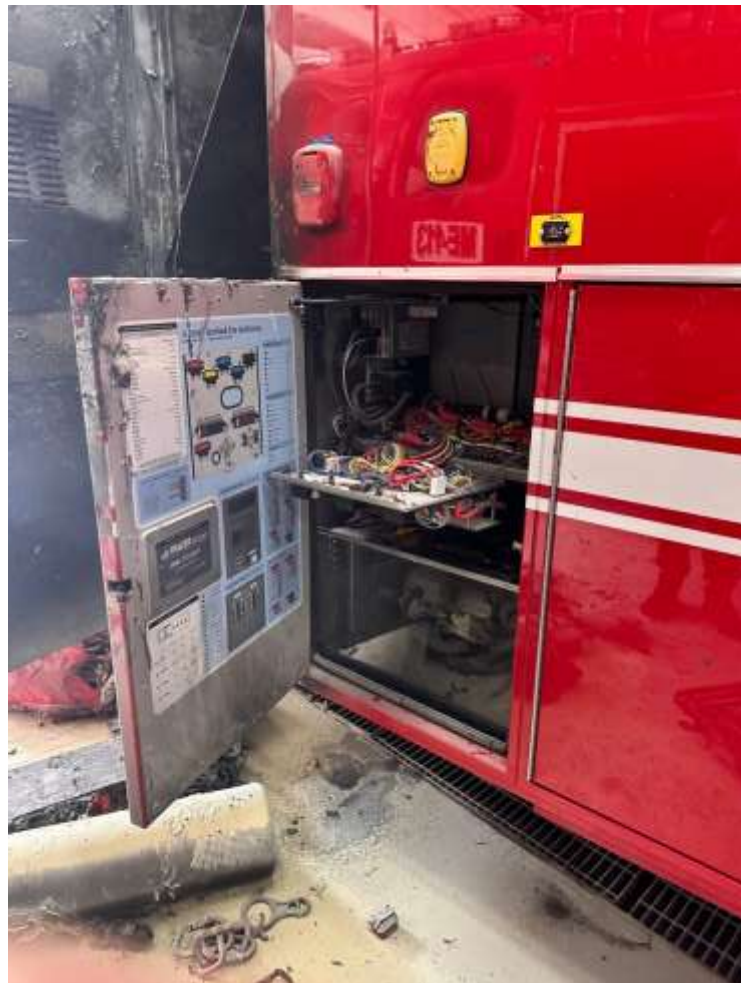
Image 6 – Side View of MA113

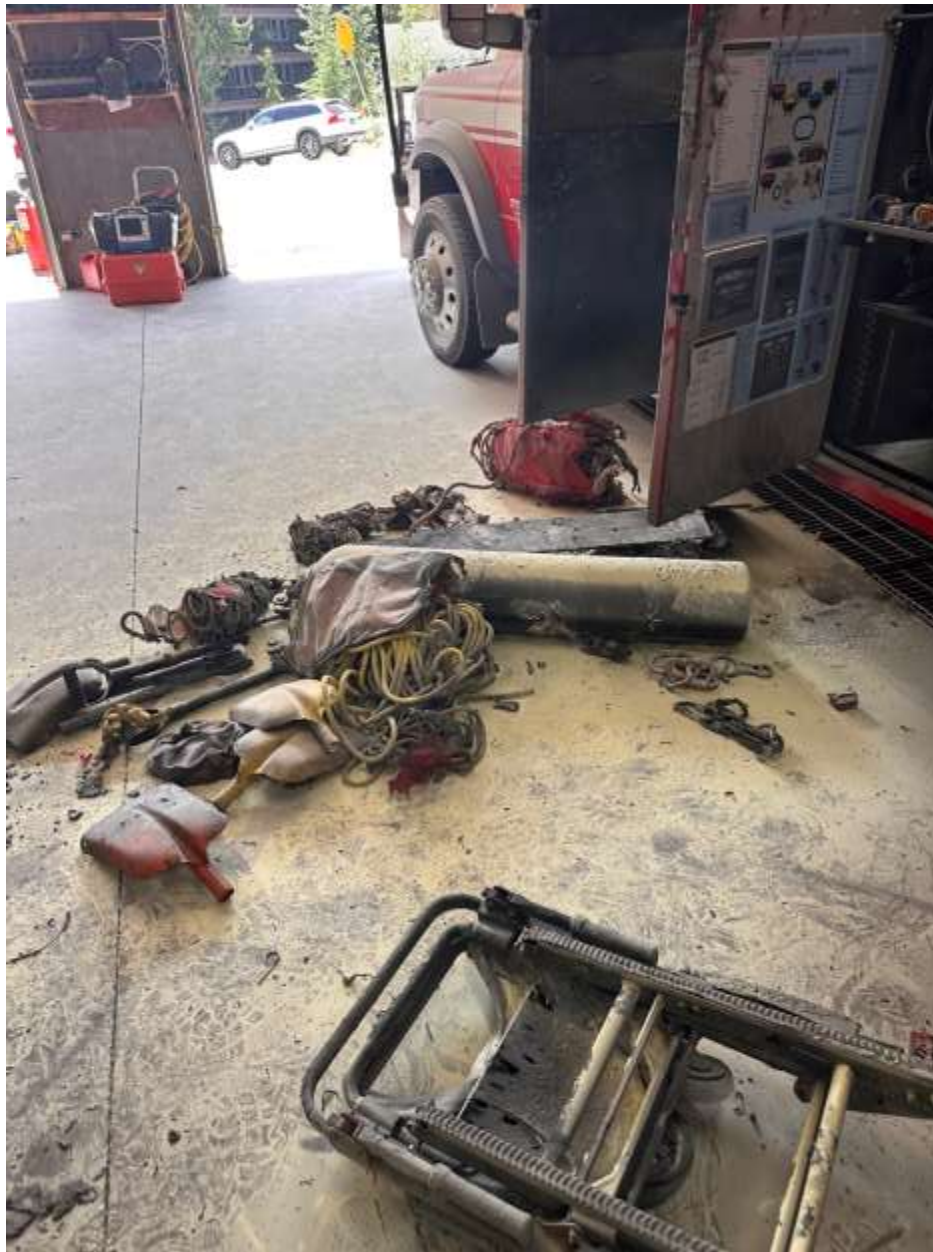
The fire and explosion severely damaged the box on Medic Ambulance 113. The most significant damage occurred to the two exterior compartments, the front (driver's side front, or D1) and the half door directly behind it (driver's side mid-door, or D2). The oxygen tank blew out of the compartment and all equipment in the oxygen compartment was destroyed, including shovels, ropes, helmets, gear and a stair chair. Within the patient compartment, most of the medical equipment was damaged beyond use, repair, or salvage. A pair of turnouts was burned in the fire and explosion. Medic Engine 113 was parked next to the ambulance and received severe damage and melted plastic across the passenger side, although no structural damage was noted.

Image 7 – View of MA113, Damaged Equipment

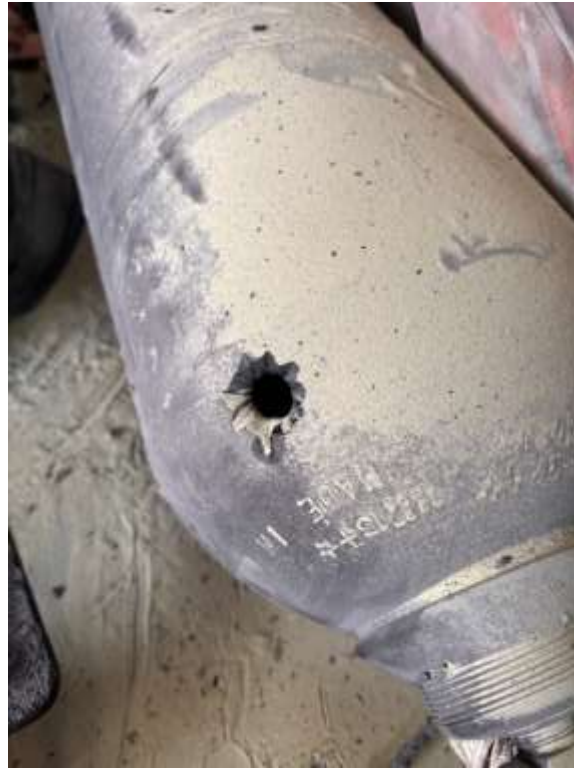
Image 8 – View of Damaged Oxygen Tank

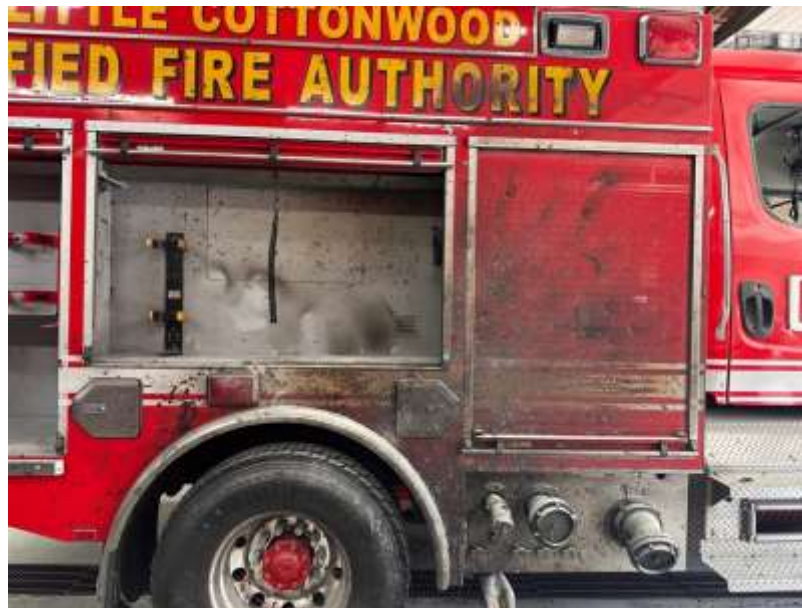
Image 9 – View of Damaged ME113

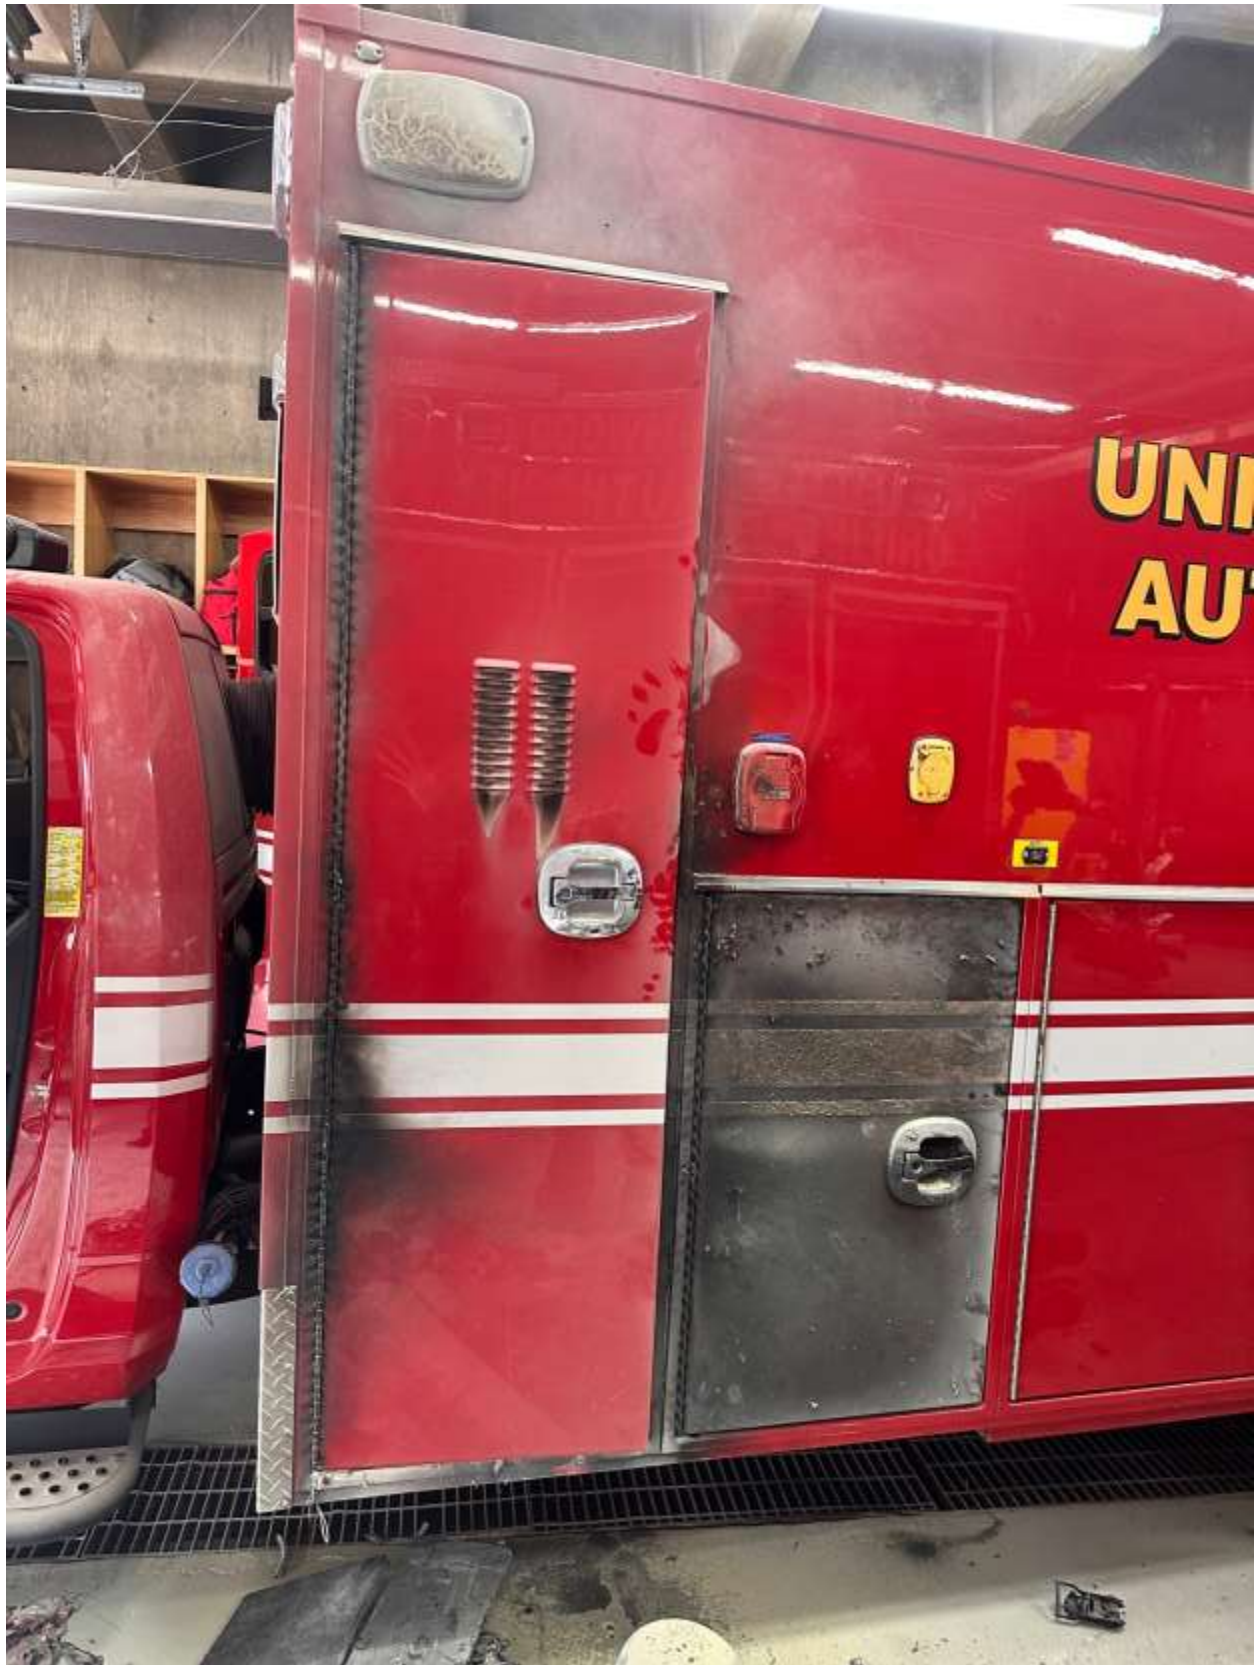
Image 10 – View of Damaged ME113 Compartments
