## Unified Fire Authority Green Sheet

### Gasoline Ignition, Riverton Garage Fire

11/09/2024, 12:53 PM

Riverton

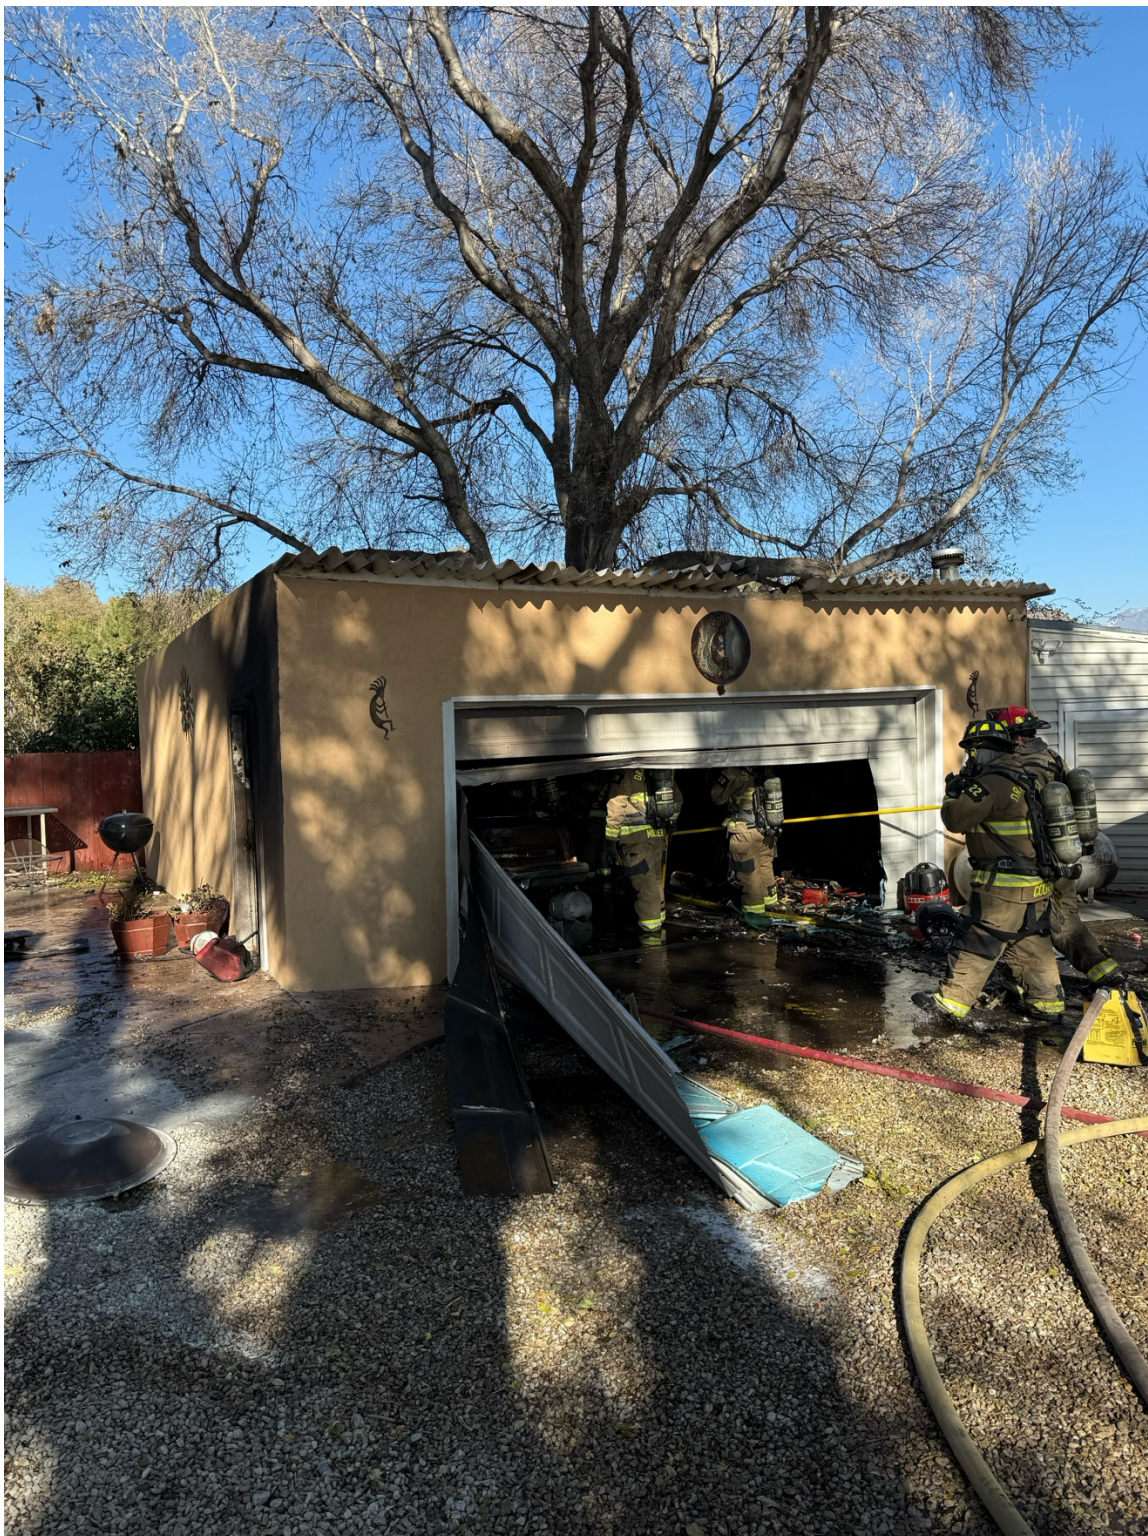
*Image 1 - View of the A/B corner of the garage*

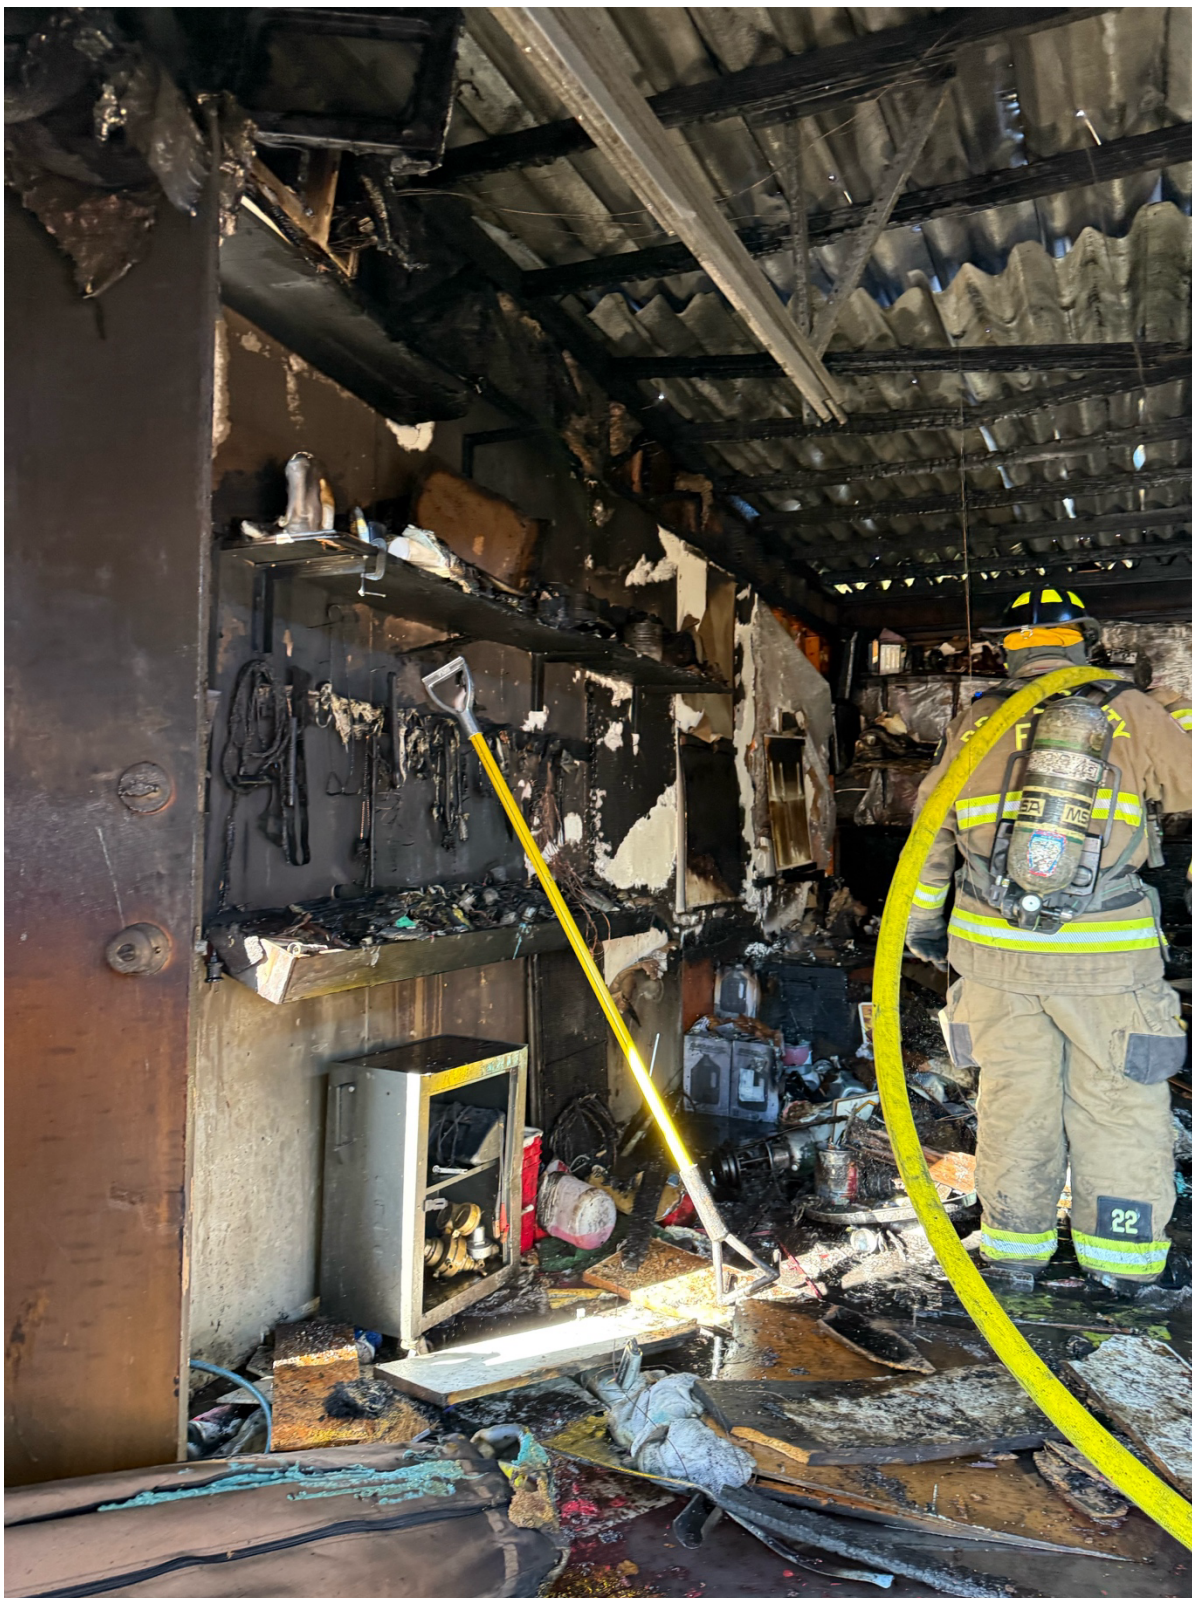
When the gasoline ignition occurred, the gas cans on the bravo side of the structure also ignited, and the additional spray of water/gas mix also ignited. When the additional water spray occurred, one Draper firefighter from ML 21 (firefighter 3) that was on the B side

*Image 2 - View of the B (bravo) side of the interior garage where the fuel was stored*

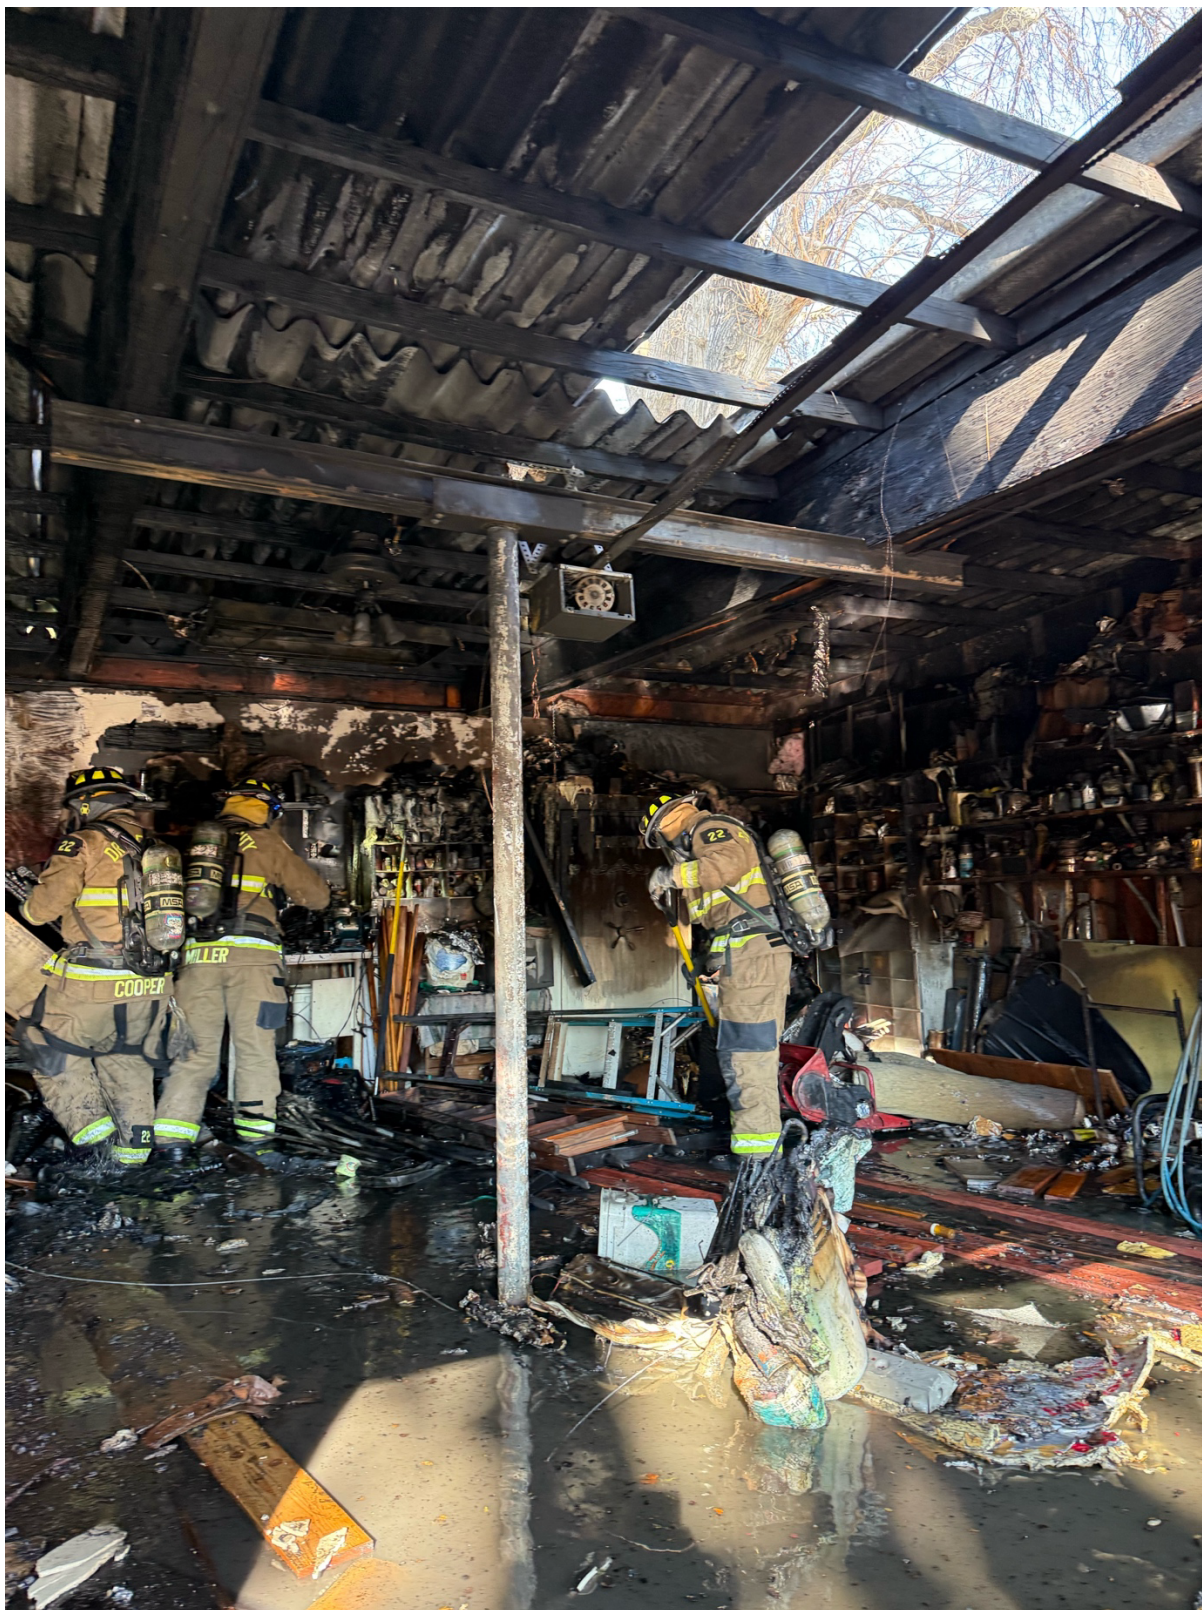
The garage itself had a lip towards the front of the garage floor that didn't allow for proper draining and flow of liquid out of the garage, thus creating a pool of liquid inside the garage. Several of the gas cans had been breached and had leaked their contents into the mixed liquid pool inside the garage. During overhaul, several more of the gas cans were being removed. One firefighter from MA 120 (firefighter 1) was exiting the garage when they felt and heard a large 'whoosh' and looked back and saw their partner from MA 120 (firefighter 2) on fire. Firefighter 1 also had flames that went underneath the turnout pant ensemble and up between the boots and pants. Firefighter 2 came out of the garage with assistance and several firefighters jumped on firefighter 2 while the suppression hose was pulled from the garage to extinguish the fire that was on the firefighter. Firefighter 2 was hit in the ear with the hose, causing additional injury to the burns they had sustained. Firefighter 2's ensemble was completely soaked in a water and gas mix which had led to the firefighter catching on fire.

*Image 3 - Interior of Garage (Notice the Pooling of the Water/Fuel on the Ground)*

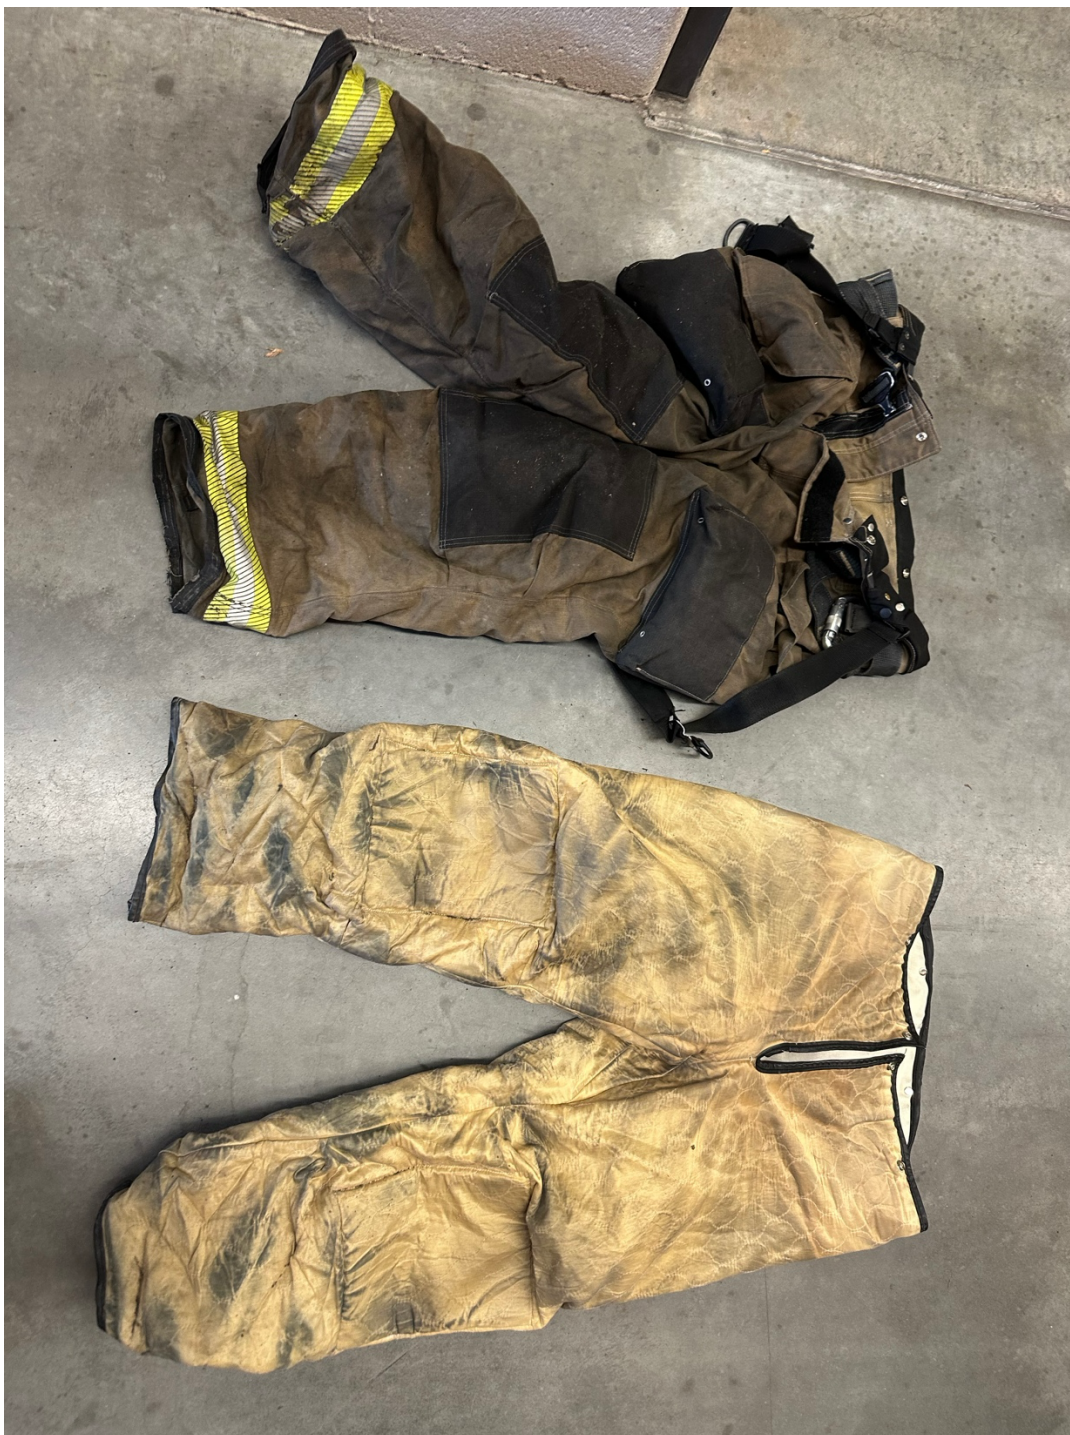
*Image 4 - Gasoline Infused Turnout Pants of FF2*

Additionally, being fully turned out, including Nomex under the turnout ensemble is recommended. Had firefighter 1 been wearing Nomex underneath the turnout ensemble, it is highly likely they wouldn't have received any of their injuries..
