# INVESTIGATION REPORT

## UNIFIED FIRE AUTHORITY

Case# UF26-19233

#### ORIGIN AND CAUSE REPORT

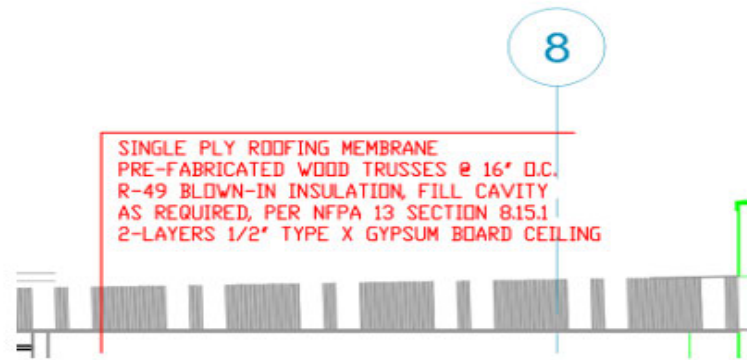
This note is on the elevation view of the fire sprinkler plans:

NO FIRE SPRINKLER PIPING  
IN ATTIC SPACE PER  
RIMROCK CONSTRUCTION

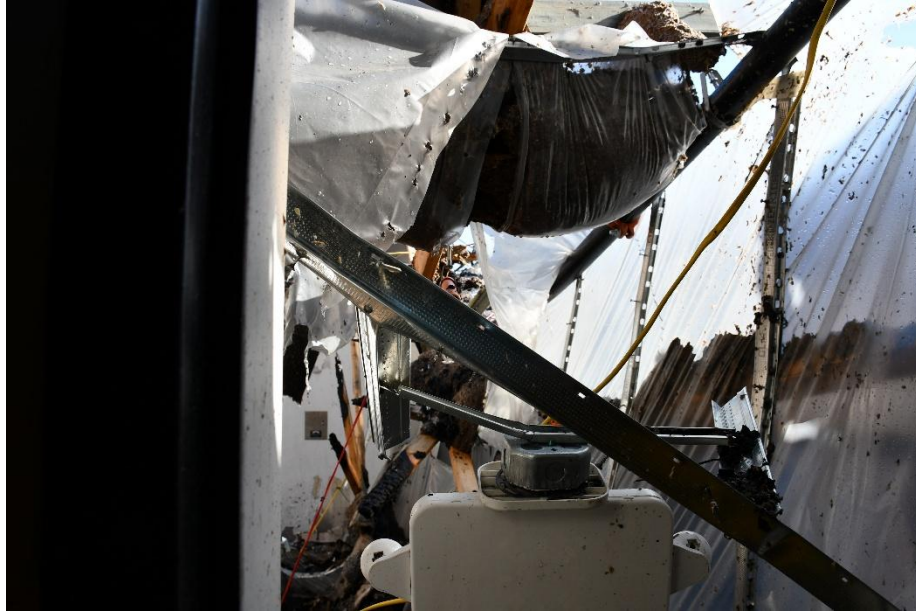
*Figure #5 Looking into the 4-floor lobby elevator access area / area of collapse.*

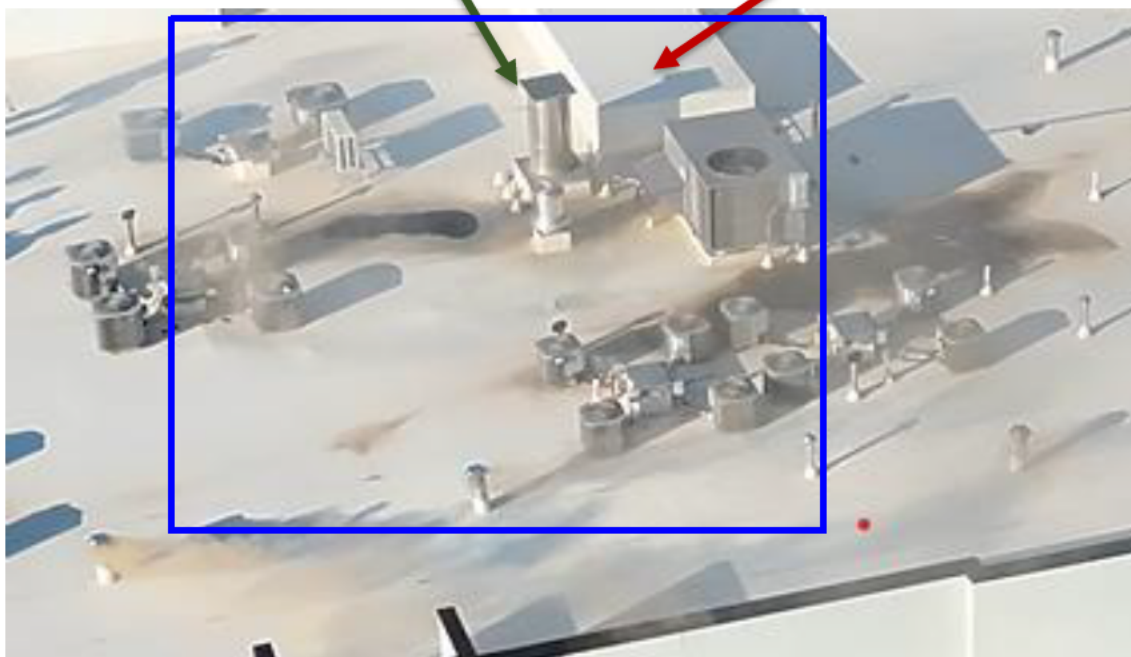
*Figure #15 Rooftop screen shot from Drone video of area of origin*

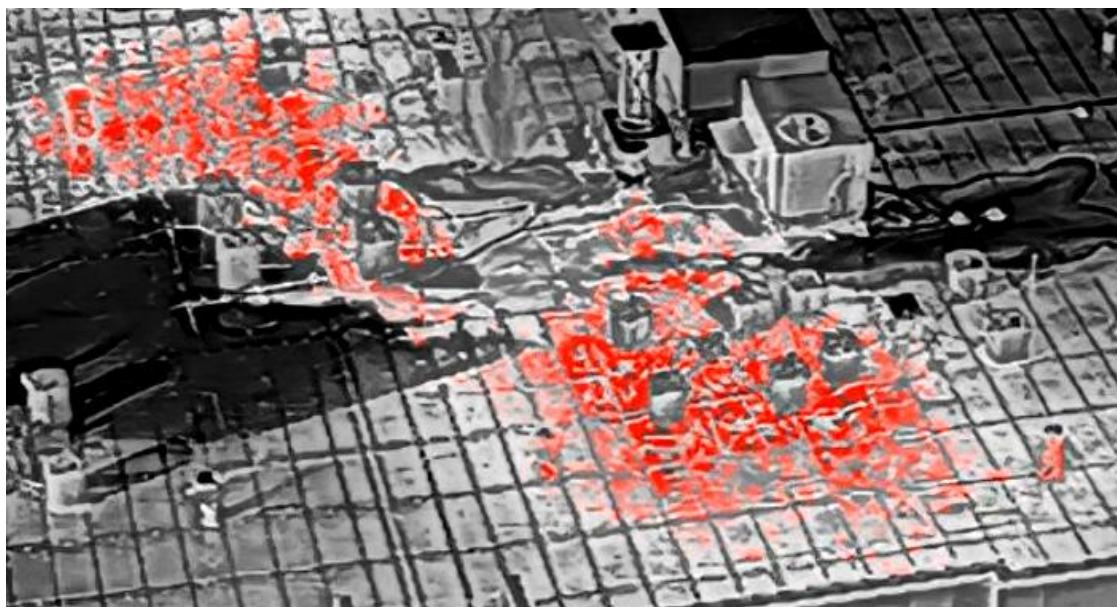
*Figure #16 Rooftop inferred screen shot from Drone video of area of origin*

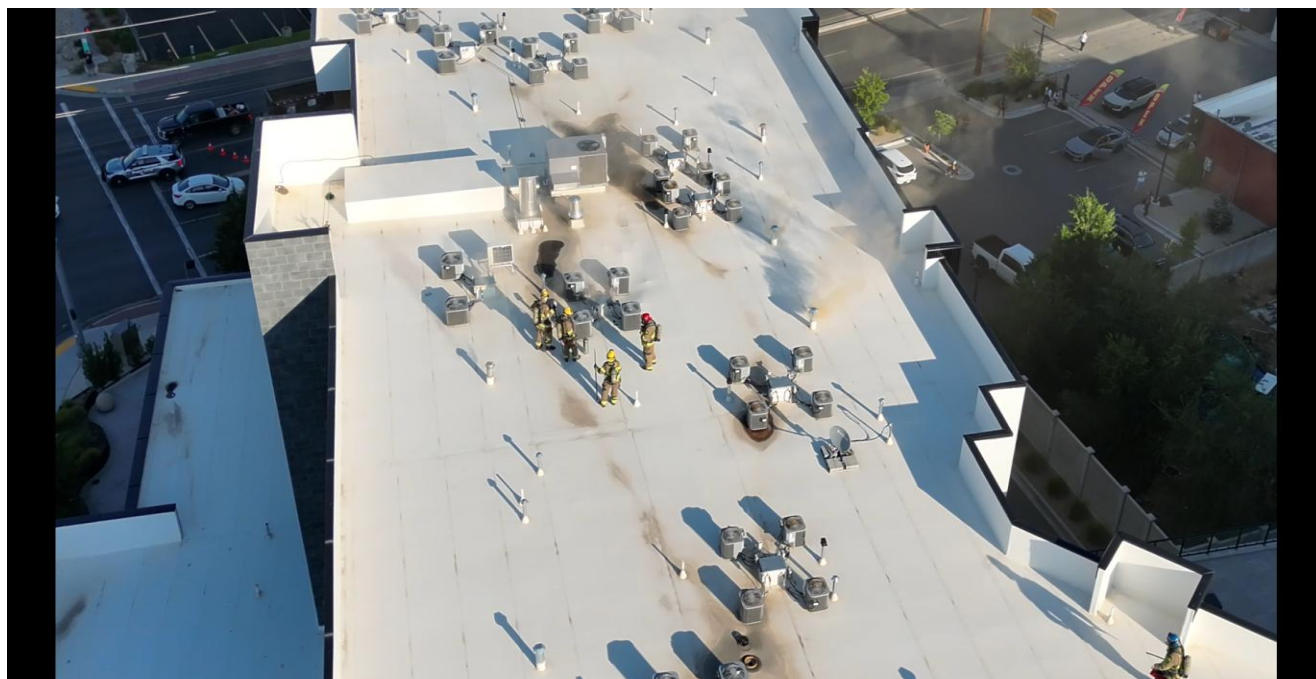
*Figure #17 Rooftop screen shot from Drone video of area of origin*

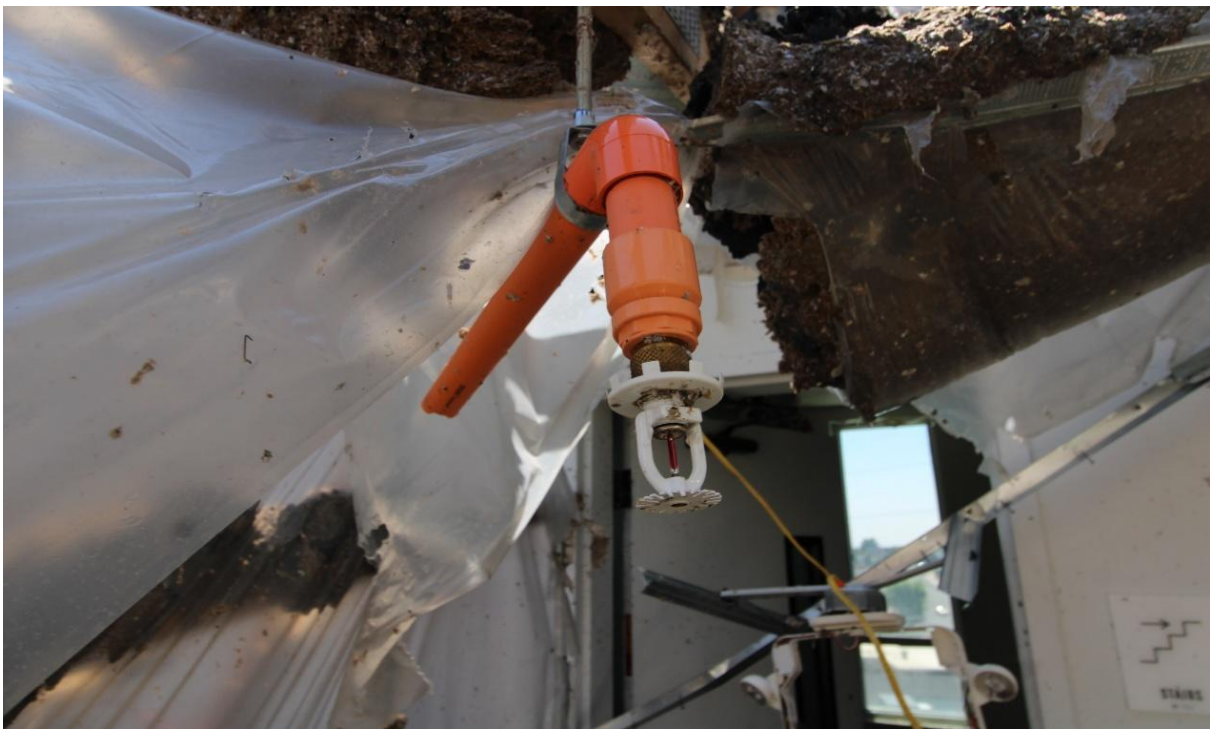
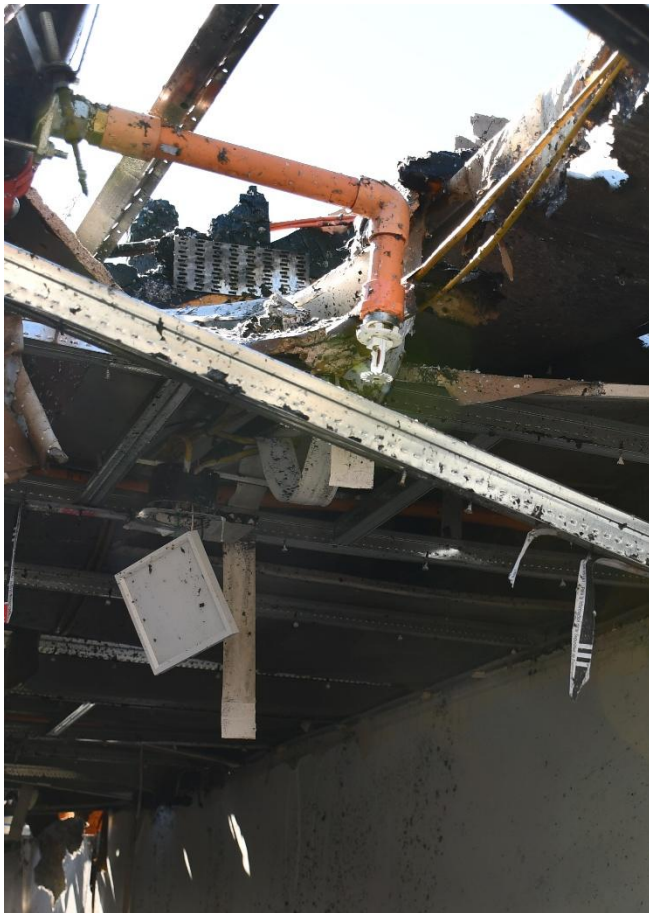
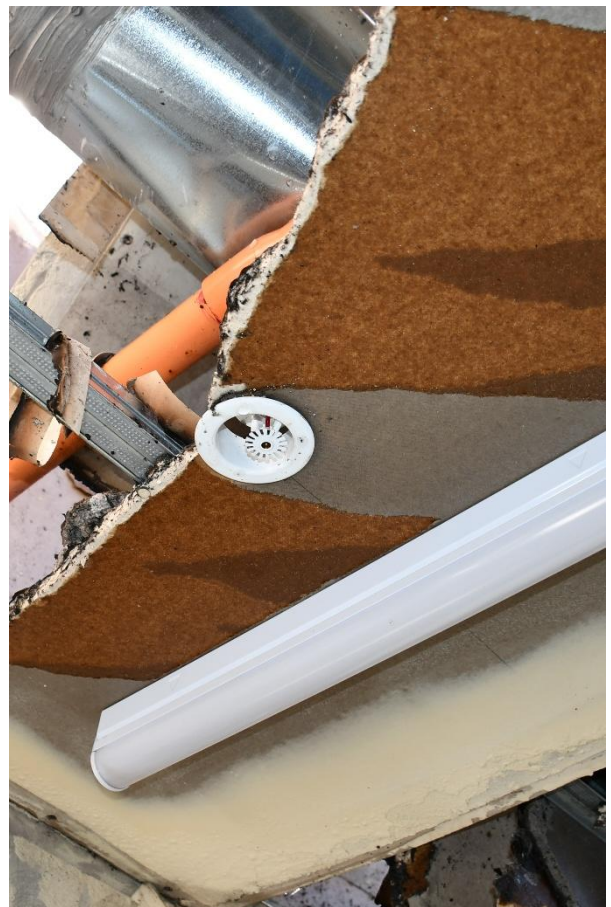
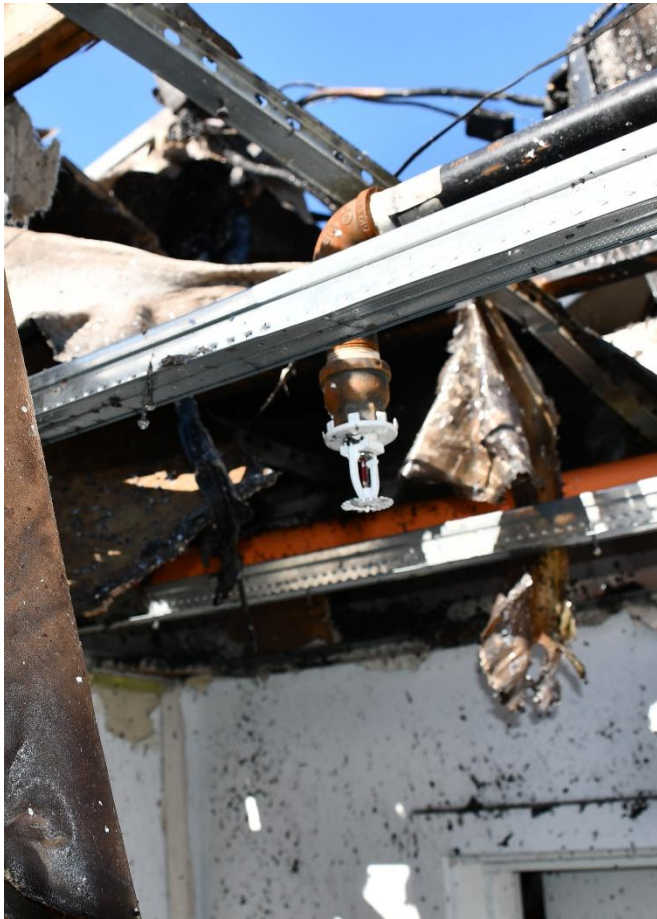
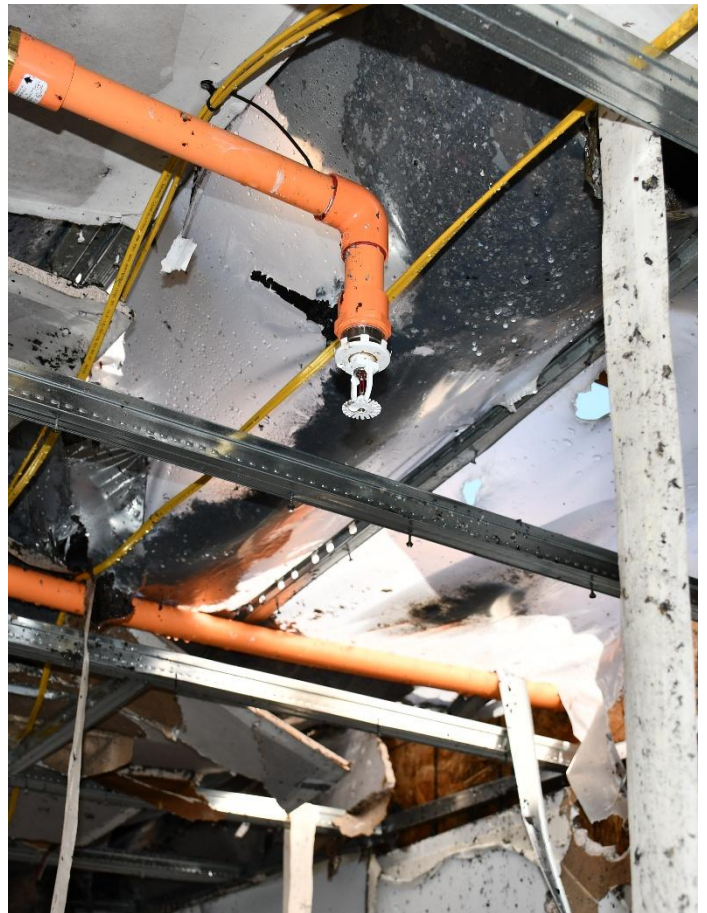
The interior examination progressed by physically going into the area of greatest damage (4<sup>th</sup> Floor by and around the elevator shaft and trash shoot and beyond examining and photographing as we processed through the area looking through the fire debris for any evidence. Investigators noted the sprinklers for the fire protection system in the area had not functioned because the heat and flame were above within the interstitial space (See photos Figure 18-22 below)

*Figure #18 Looking at the Fire Sprinkler system*

*Figure #19-20 Looking at the Fire Sprinkler system*

*Figure #21-22 Looking at the Fire Sprinkler system*

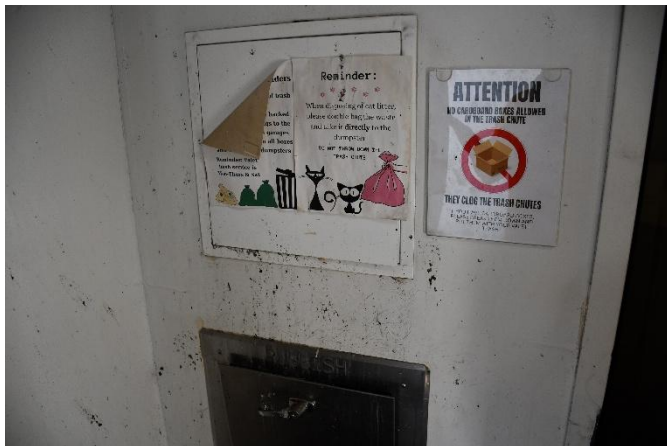
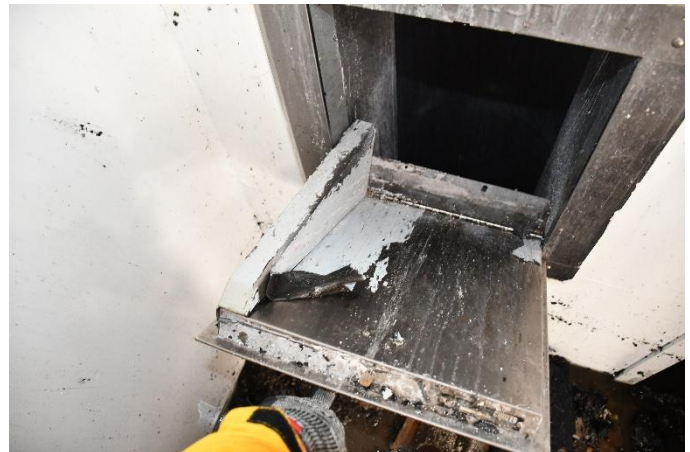
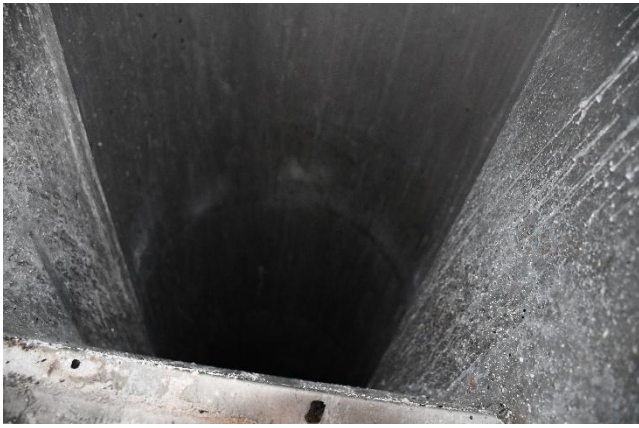
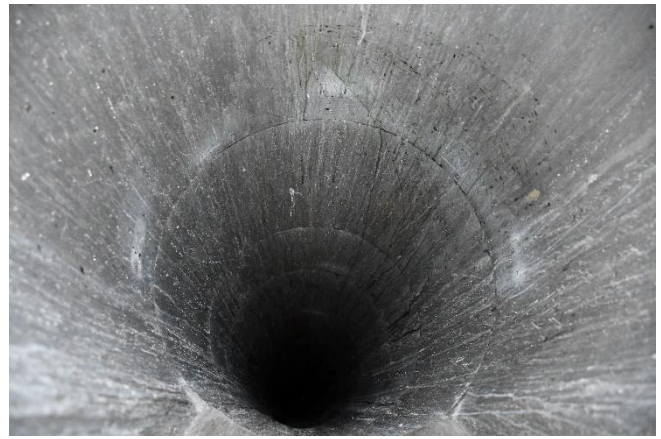
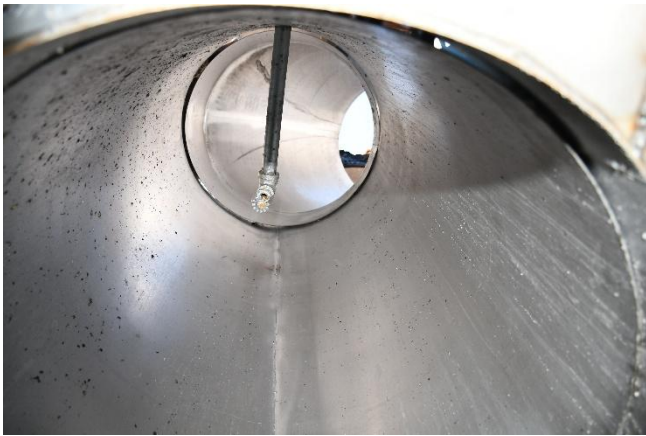
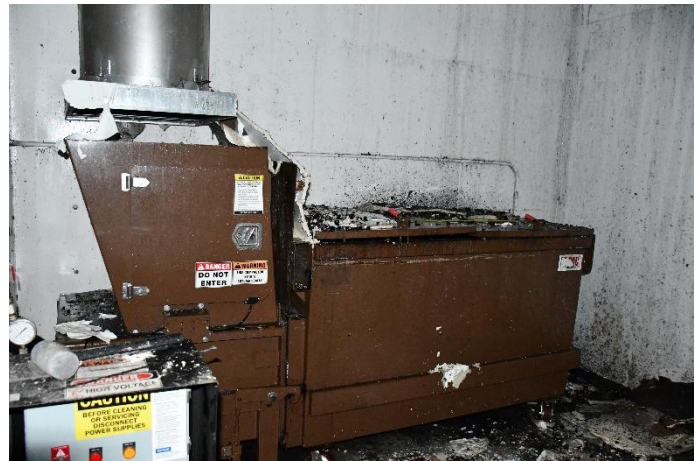
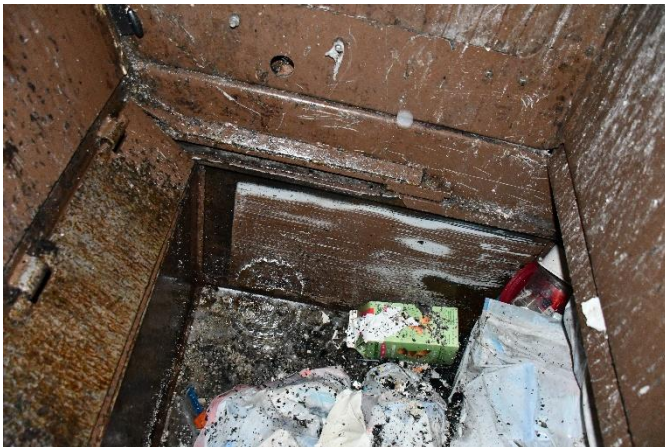
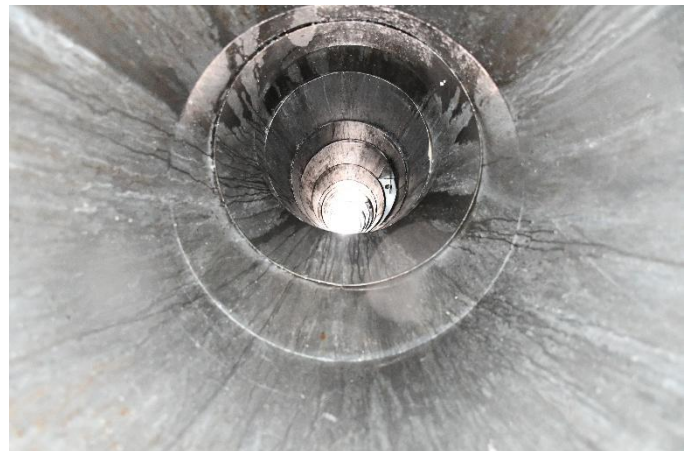
Investigators examined the garbage chute due to reports that smoke had been observed coming from the chute during the early stages of fire suppression operations. The interior of the garbage chute was examined for evidence of direct flame impingement, burning, or heat damage.

No noticeable evidence of open-flame burning or significant heat damage was identified within the garbage chute. Investigators also examined the lower portion of the chute, including the collection bin and compactor. Neither the collection bin nor the compactor exhibited damage consistent with direct fire involvement.

The lack of observable fire damage within the garbage chute, collection bin, and compactor does not support the garbage chute as an area of sustained open-flame fire involvement.

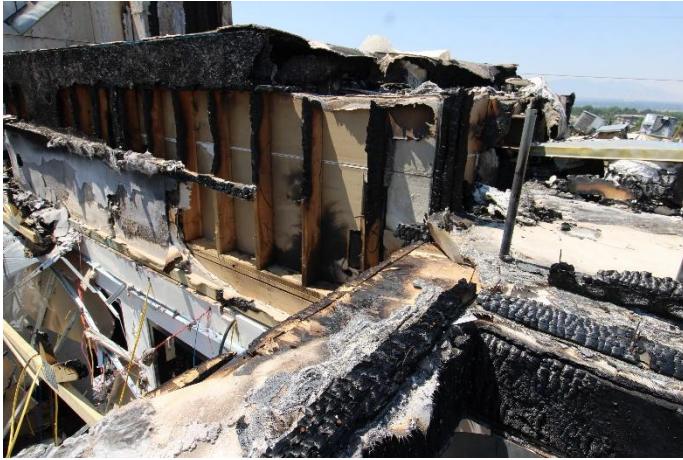
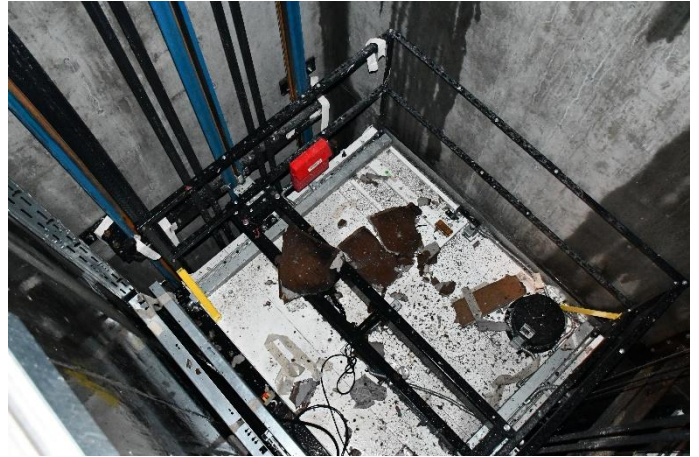
The elevator was in full operation at the time of the fire. No damage was observed to the elevator wiring or electrical connections. All cables and pipes examined appeared to be in good working condition. Damage was observed above the elevator shaft in the area where the elevator mechanical equipment and controls may be located.

*Figure #31 Looking at the elevator section from the roof level  
Figure #32 looking down at the elevator shaft from above*

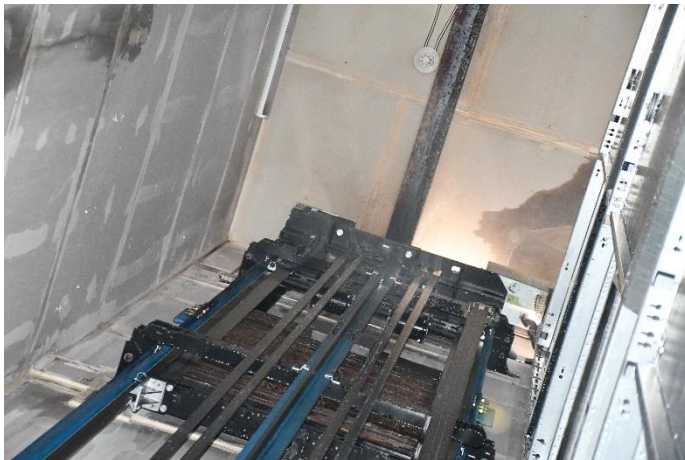
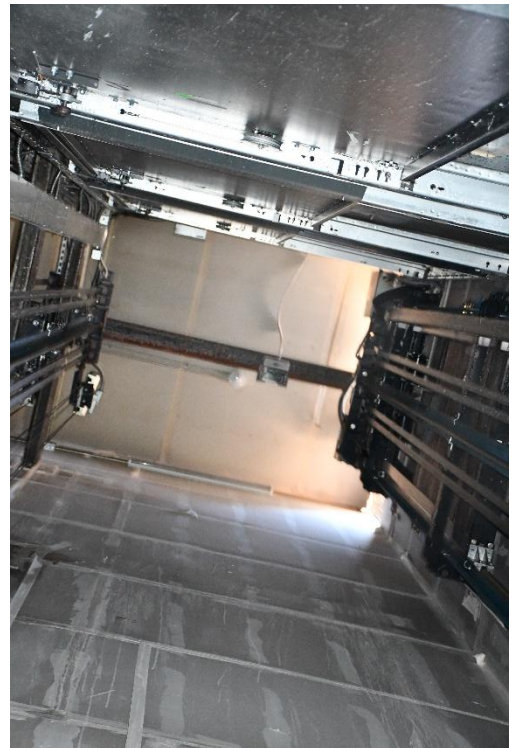
No noticeable evidence of open-flame burning or significant heat damage was identified within the elevator shaft. The shaft did not exhibit damage patterns consistent with direct fire involvement.

*Figure #33 Looking up the elevator shaft towards the roof level  
Figure #34 Looking up the elevator shaft towards the roof level*

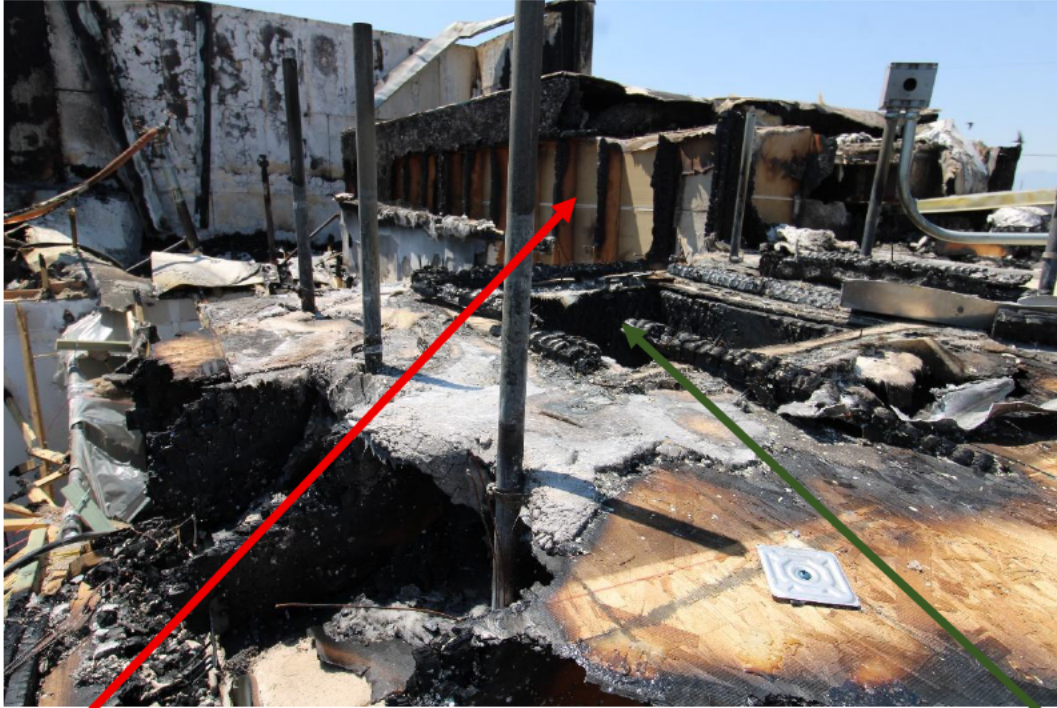
Review of the available drone imagery identified significant fire involvement within the upper interstitial and roof areas. The greatest observed fire involvement was concentrated in the vicinity of the two separate rooftop air-conditioning unit installations serving Units 406 and 407, including the area between the units. Comparatively, the imagery showed limited fire involvement in the vicinity of the elevator and trash chute.

*Figure#35 Looking at the burn patterns from Hallway towards the elevator*

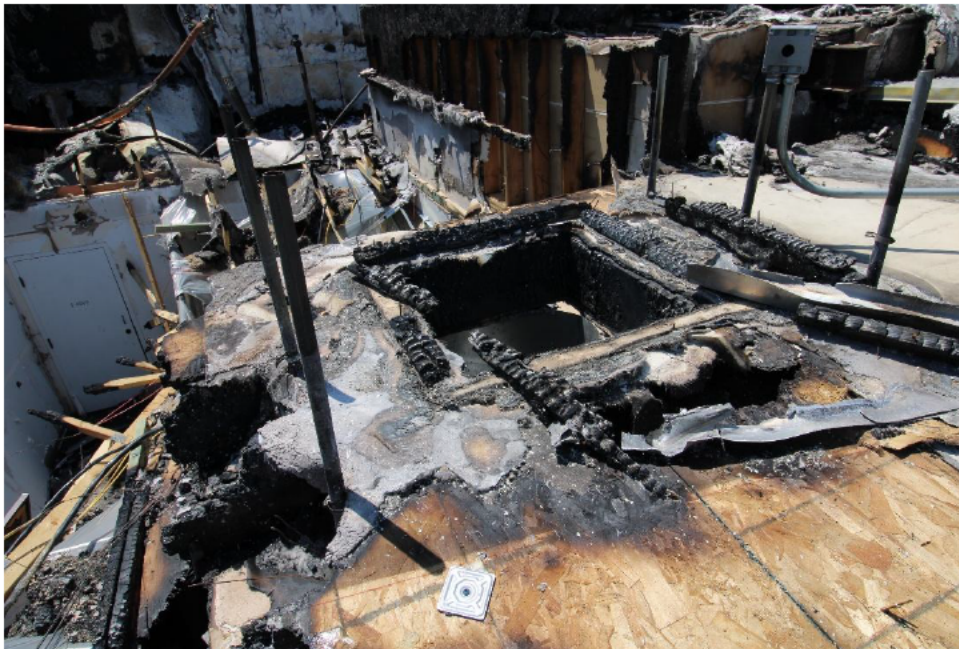
*Figure #36 another angle from Hallway towards the elevator*

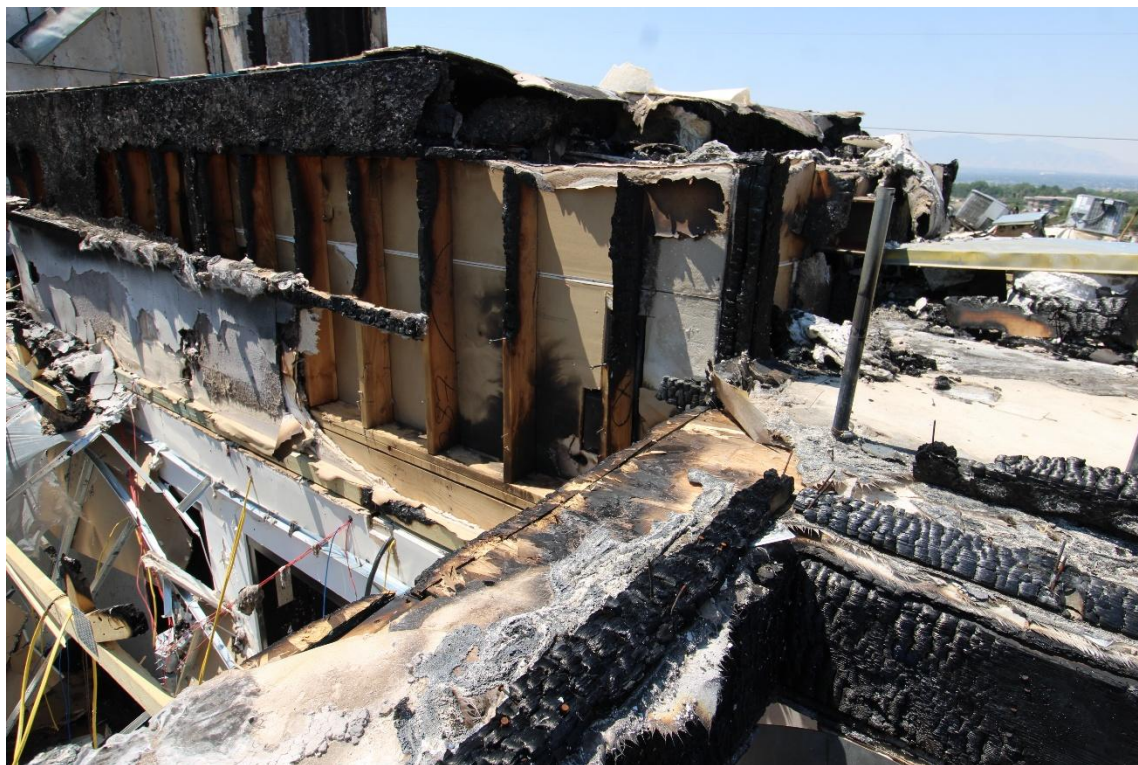
*Figure #38 Close up of Elevator area*

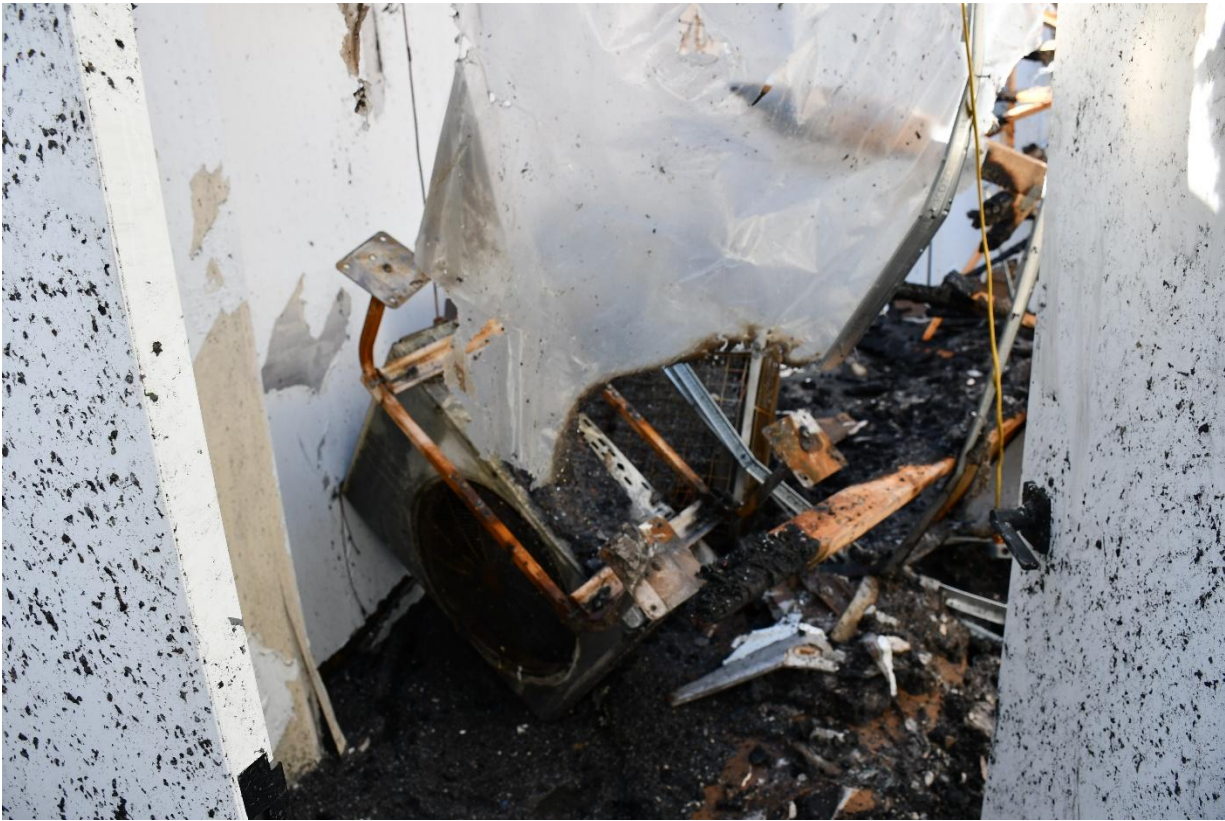
*Figure #49 air-conditioning units & Debris in collapse zone*

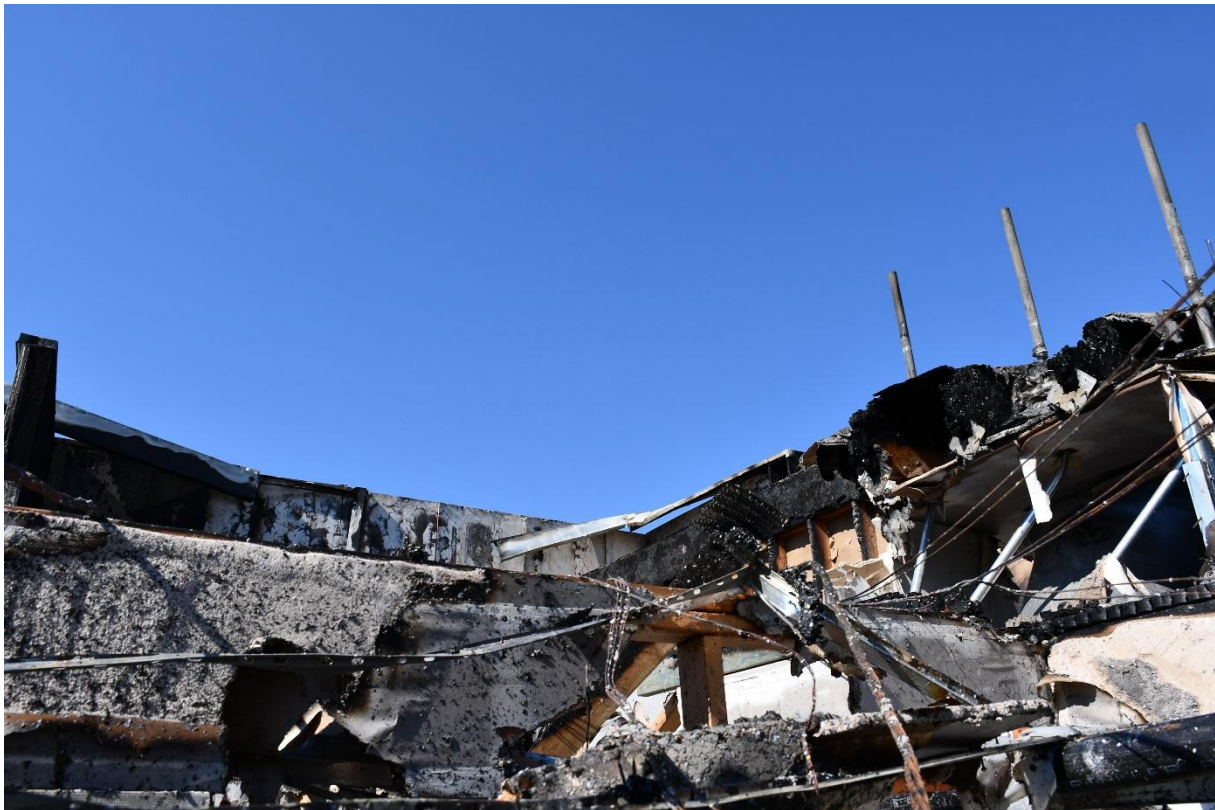
*Figure # 50 Looking at a burn damage from below in 4<sup>th</sup> floor*

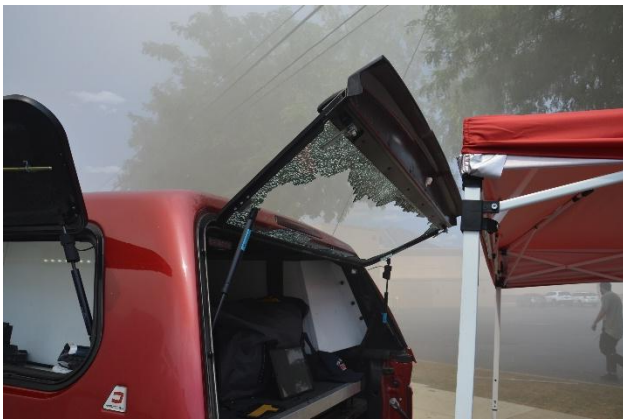
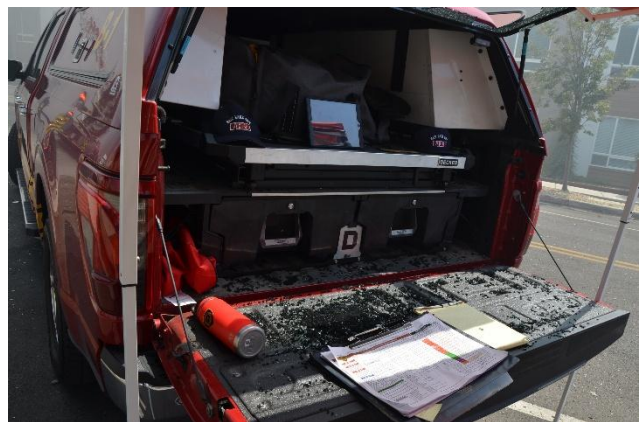
The Salt Lake City Battalion Chief's vehicle sustained damage from falling debris from a smoke explosion that occurred while suppression operations were being conducted. The vehicle damage was attributed to falling debris associated with the suppression activities and was not identified as fire damage to an exposure.

*Figure #51 SLC BC1 Vehicle Damage*

*Figure #52 SLC BC1 Vehicle Damage*
